XRAY NTH

2-SPEED SHAFT WEAR INSPECTION

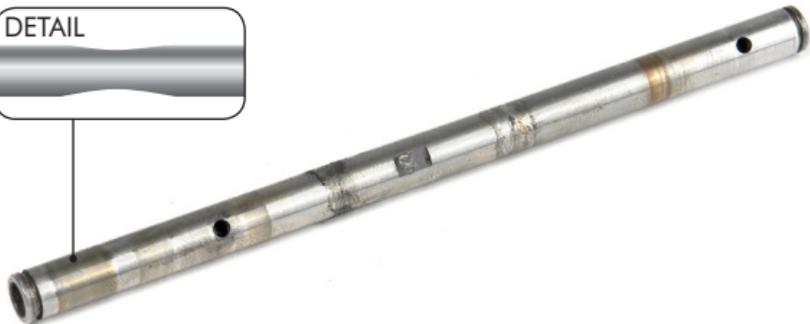
We recommended that you frequently check the 2-speed shaft (#335510) for excessive wear. When the 2-speed shaft is worn, the one-way bearing can stack and this can cause teeth to break on the spur gear. Therefore, when the 2-speed shaft is excessively worn, you should exchange it for a new one.
