# XRAY M18T

## TECH TIP: MODIFICATION OF SERVO HOLDERS

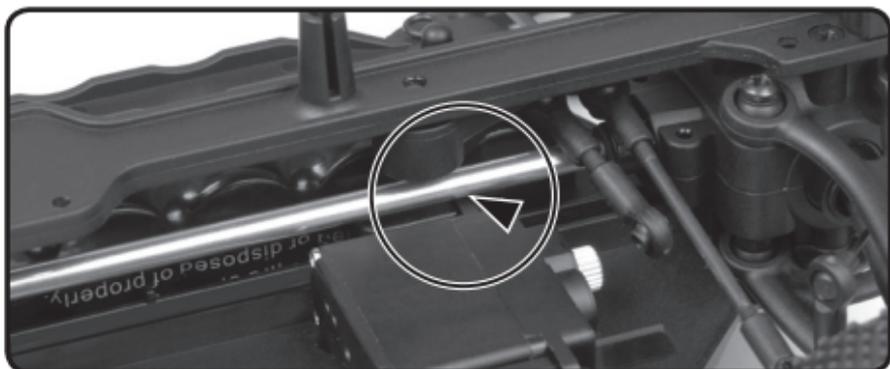
Some servos may get into contact with the central aluminum layshaft and this can brake the free action of the transmission. It is suggested to slightly modify the holder of the servo.

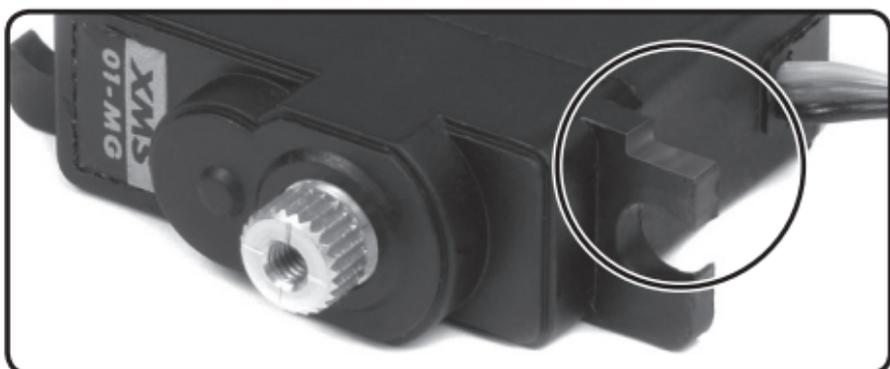
View on the finished modification
